NAVAER 00-75-510

THE NAVAL AVIATION SAFETY REVIEW

July 1959

approach for JULY 1959

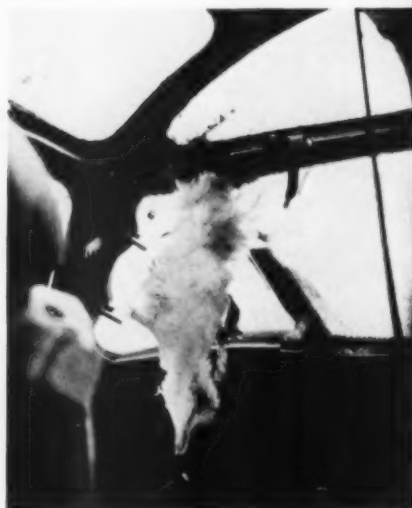
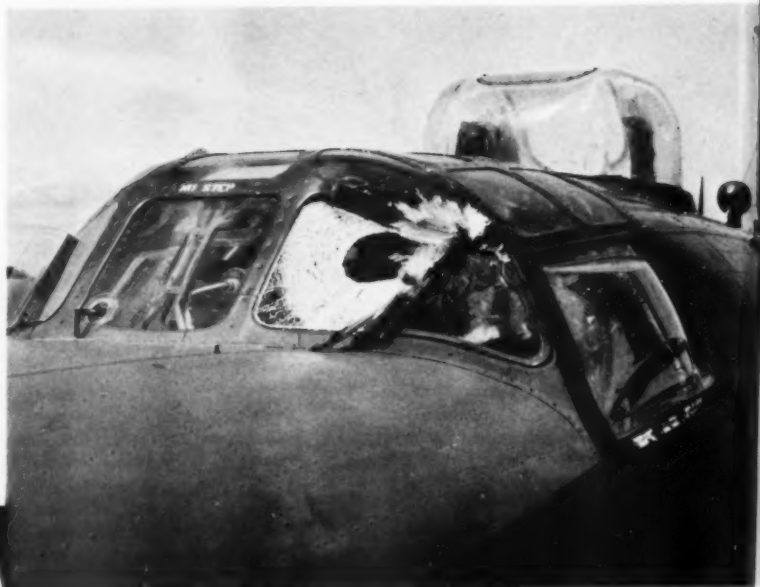
AERIAL ENGAGEMENT—Seagull strike on windshield area of P4Y (above) during low altitude bombing run shattered windshield, struck pilot in face and head, photos left and right. Pilot in right seat took over controls and flew plane back to base without further difficulty. Pilot sustained minor injuries.

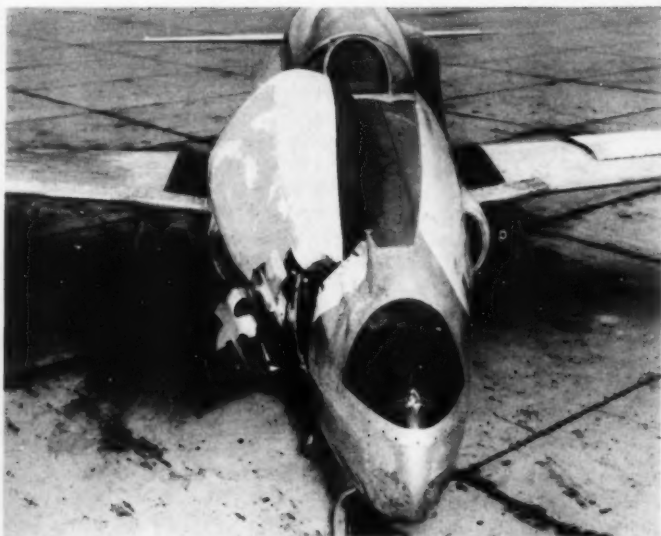
FEATHERED FRIEND (?) During straight and level flight bird struck starboard gun bay door of TV-2, left. Bird went into A4D's engine, right, necessitating an engine change.

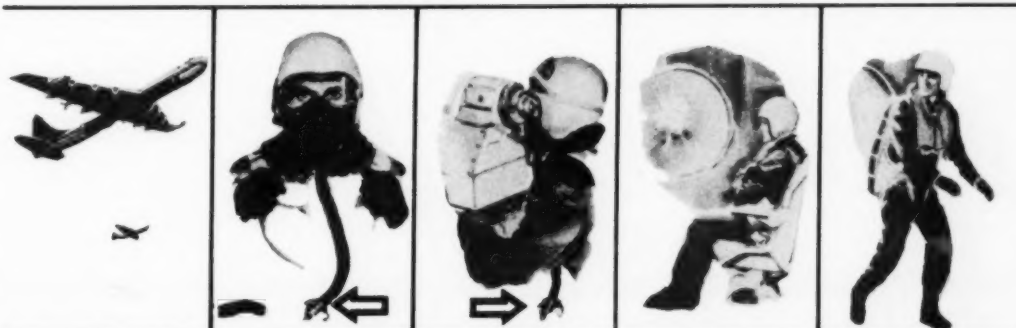
TIME OF USEFUL CONSCIOUSNESS

FEET OF ALTITUDE

RAPID DISCONNECT (Sitting Quietly)	RAPID DISCONNECT (Moderate Activity)	EXPLOSIVE DECOMPRESSION (Sitting Quietly)	EXPLOSIVE DECOMPRESSION (AND BAIL-OUT)
22,000 _____	10 min. _____	5 min. _____		
25,000 _____	3 min. _____	2 min. _____	2 min. _____	1 min. _____
28,000 _____	1½ min. _____	1 min. _____	1 min. _____	½ min. _____
30,000 _____	1¼ min. _____	¾ min. _____	¾ min. _____	20 sec. _____
35,000 _____	¾ min. _____	½ min. _____	½ min. _____	15 sec. _____
40,000 _____	30 sec. _____	18 sec. _____	23 sec. _____	15 sec. _____
65,000 _____	12 sec. _____	12 sec. _____	12 sec. _____	12 sec. _____

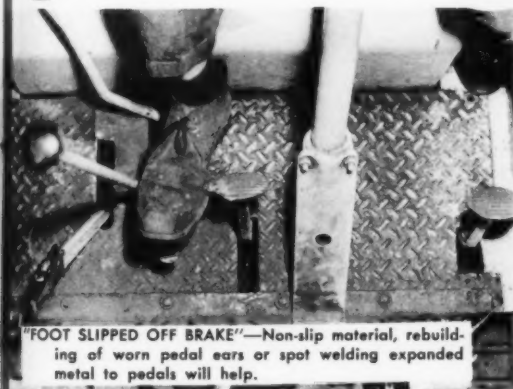
"FOOT SLIPPED OFF BRAKE"—Non-slip material, rebuilding of worn pedal ears or spot welding expanded metal to pedals will help.

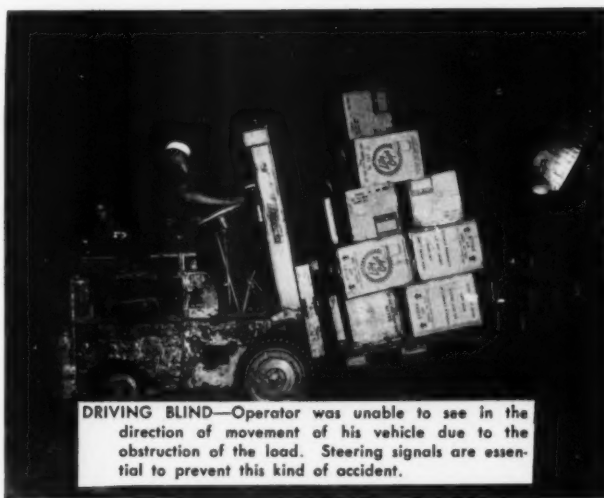
DRIVING BLIND—Operator was unable to see in the direction of movement of his vehicle due to the obstruction of the load. Steering signals are essential to prevent this kind of accident.

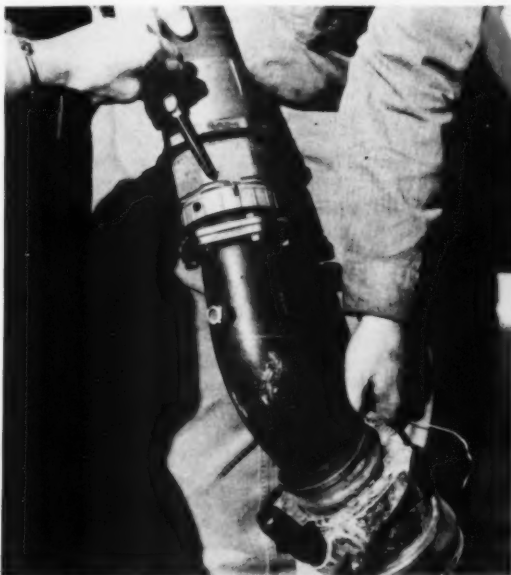
Lack of a lockwire caused the hose coupling to drop free of fueling nozzle spraying fuel into the after fuselage bay and onto the deck around A4D-2. Flight line personnel subdued fire, apparently ignited by hot engine. Photo above shows correct installation of lockwire.

FUEL NOZZLE CHECK—Soon after returning from a flight, an A4D-2 was being refueled. The plane captain connected the single-point fueling nozzle in the after fuselage bay, and the refueler driver began pumping fuel to the aircraft. Almost immediately the hose coupling at the fueling nozzle dropped free and fuel sprayed into the after fuselage bay and onto the deck below the plane before the driver could stop the flow.
